1、 Part name :180809 Spule V2 #2

13、 Type of Mold : **Production Mould**

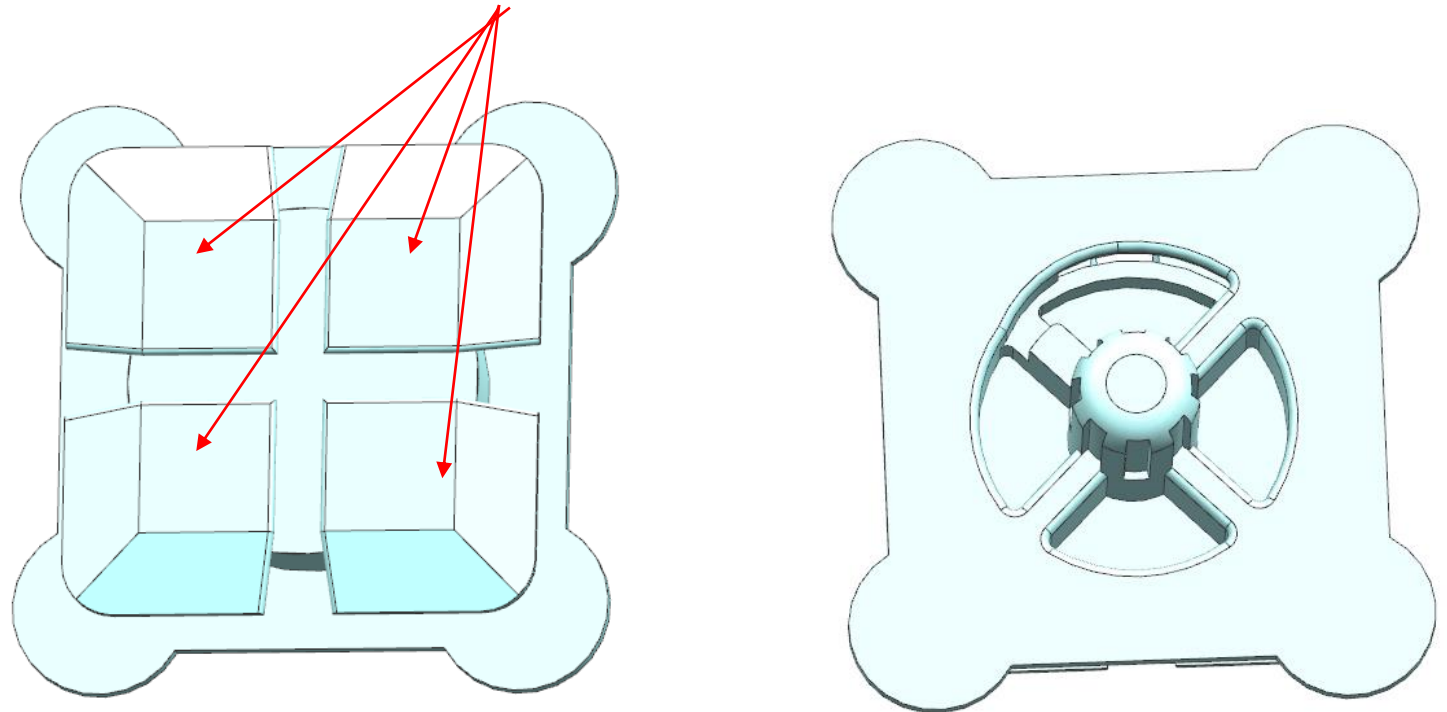
What is surface requirement for this side? VDI texture or ?

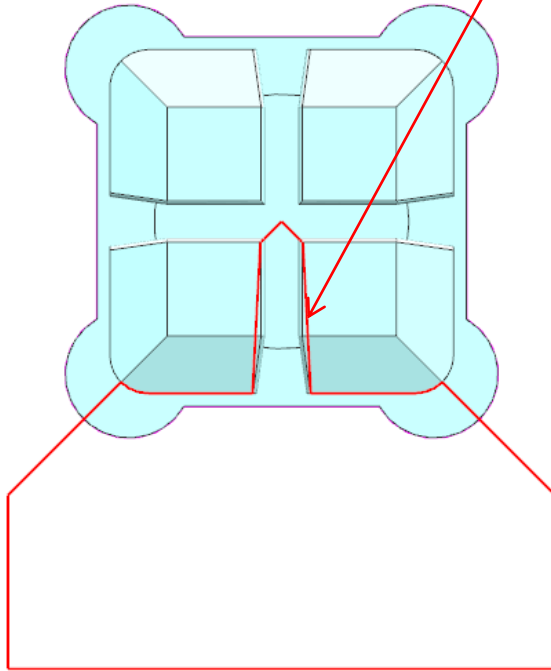
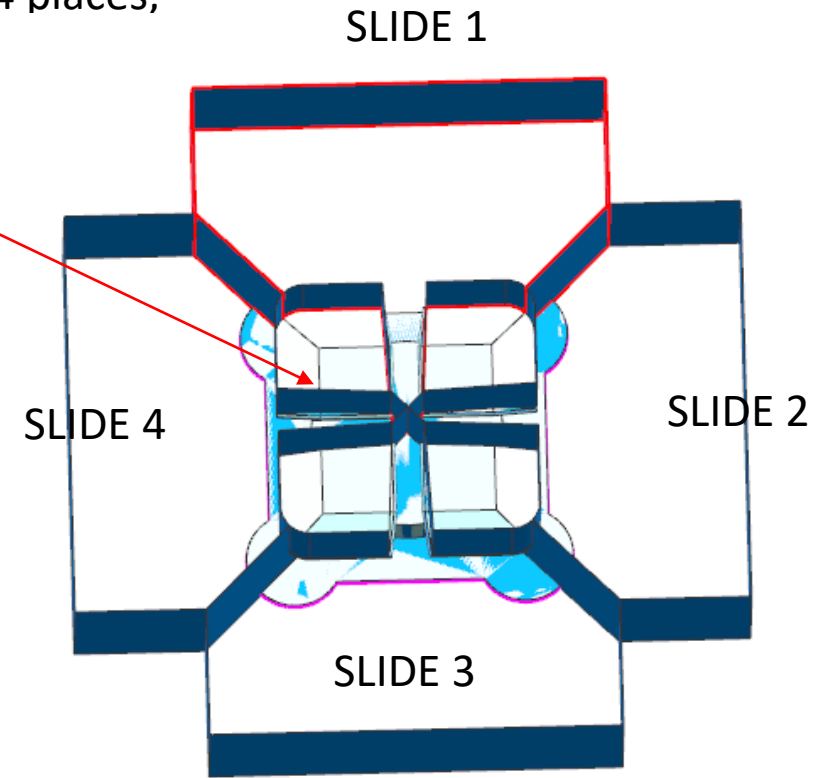
Slider parting line will be like this, total 4 places,
please check and confirm?

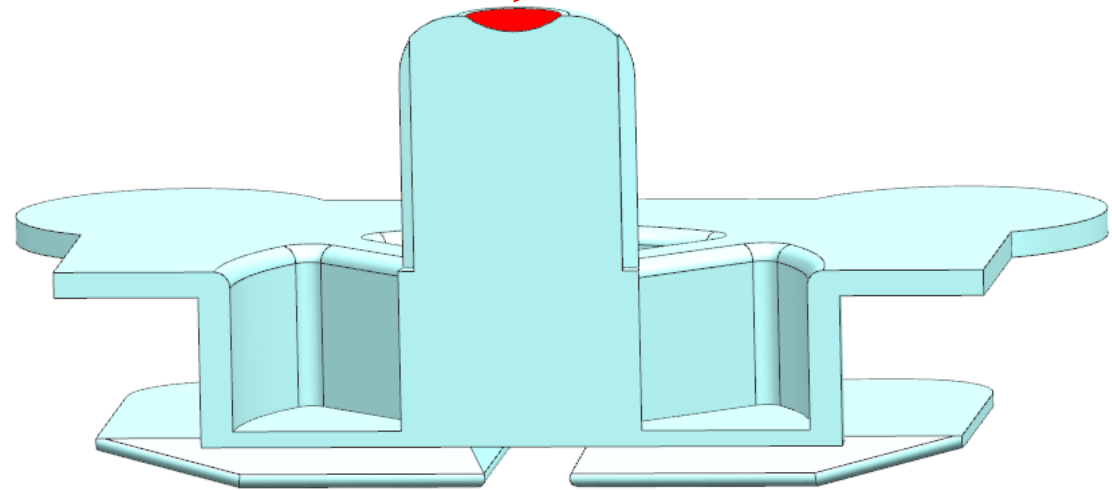
To avoid the gate vestigial here, we suggest to reduce some plastic and make dimple here, size will be 3 x 0.5mm(deep), please confirm?

YUDO hot runner two drops, one drop to one part,
This is gate point

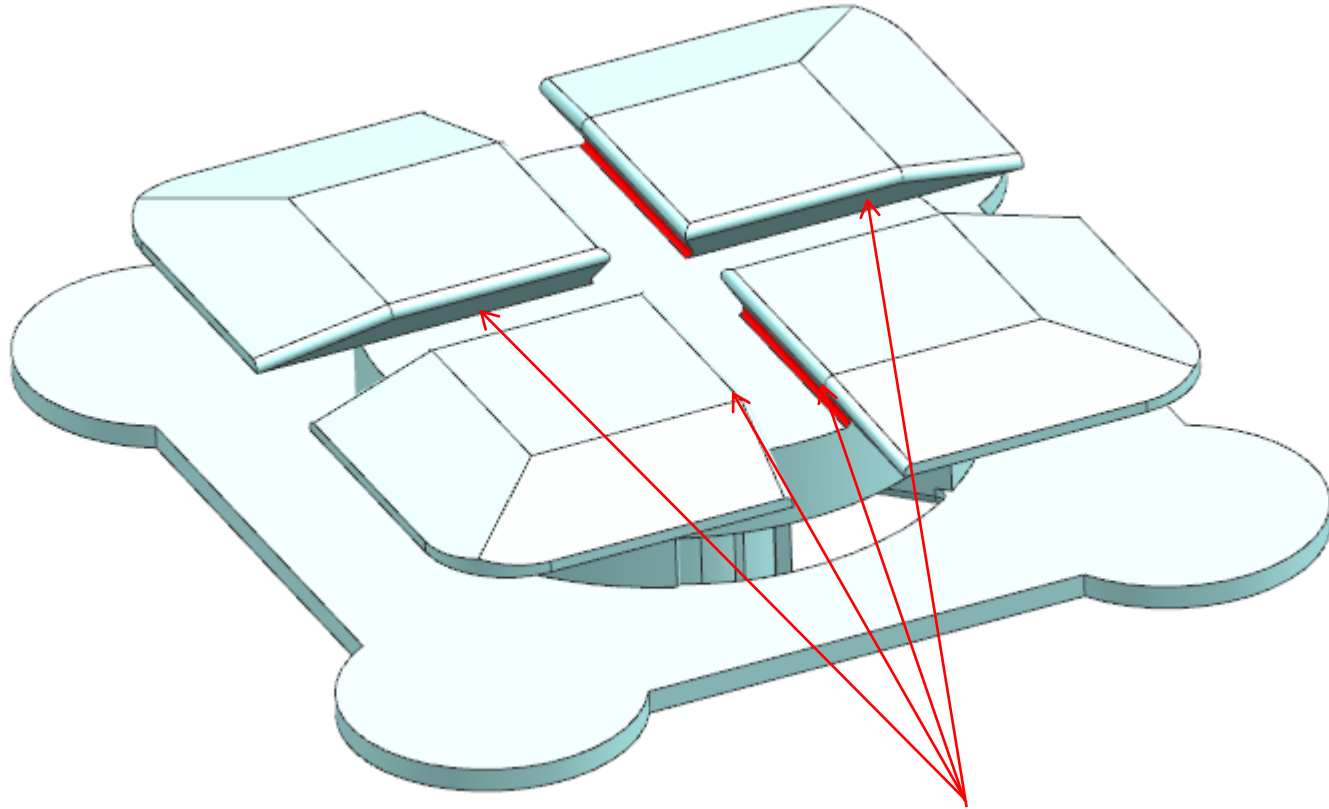
Some of area that has radius and some area does not have any radius, please check the part design and confirm ?

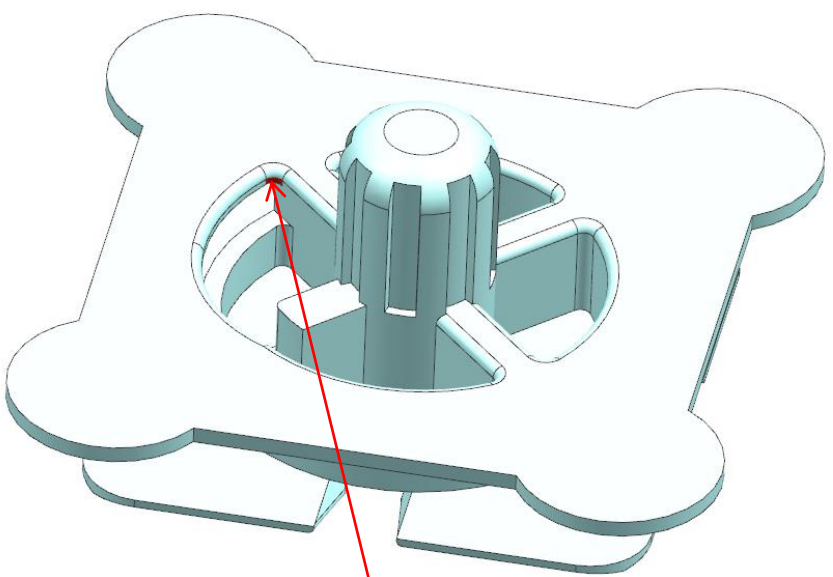
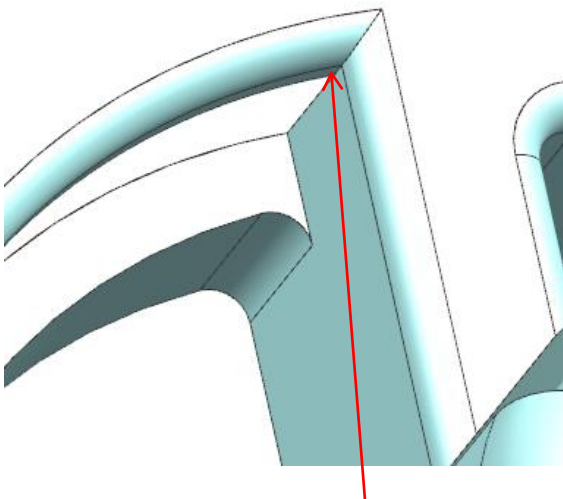
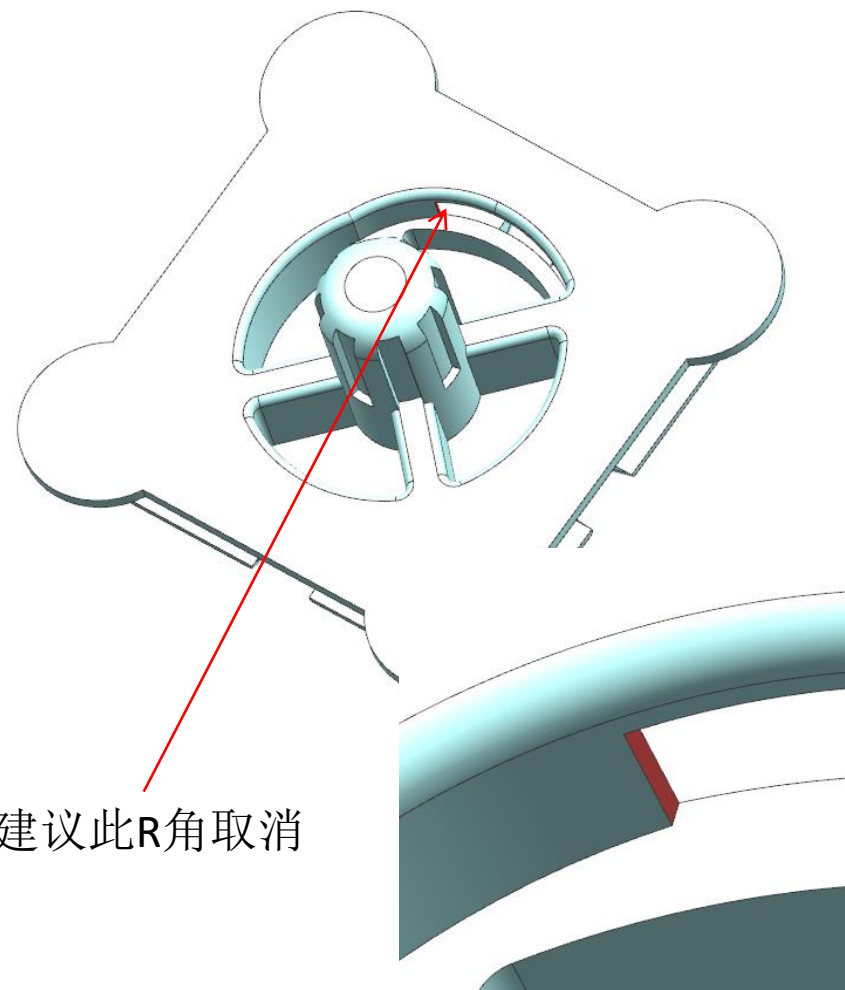
Suggest to check that area to

After change

建议此R角取消

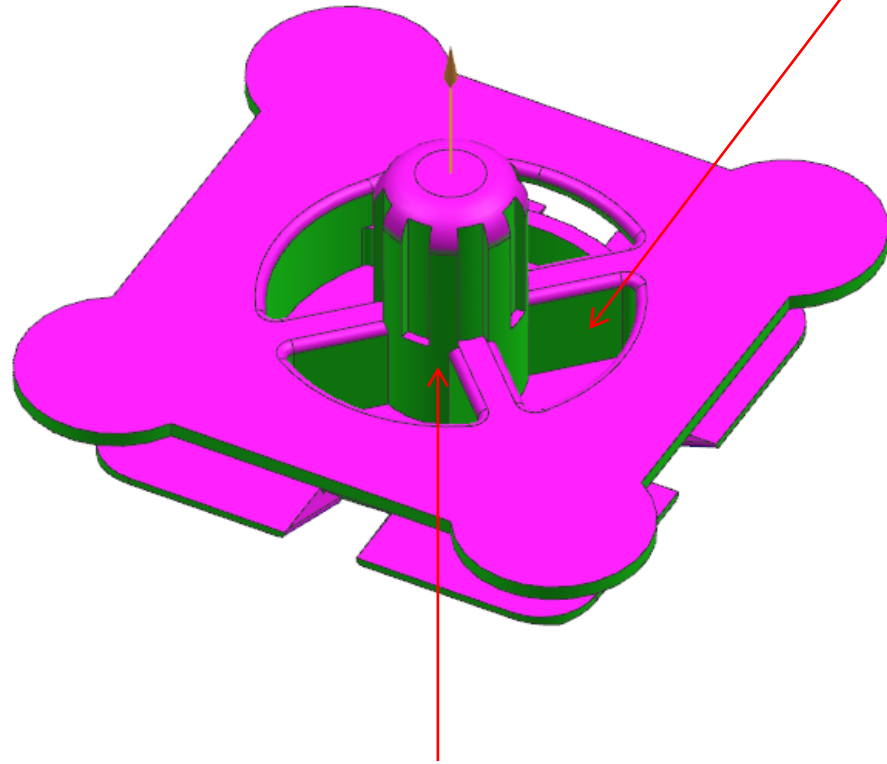
The green area does not have any draft angle,
we suggest to add 1.5 draft angle, to all of similar ribs

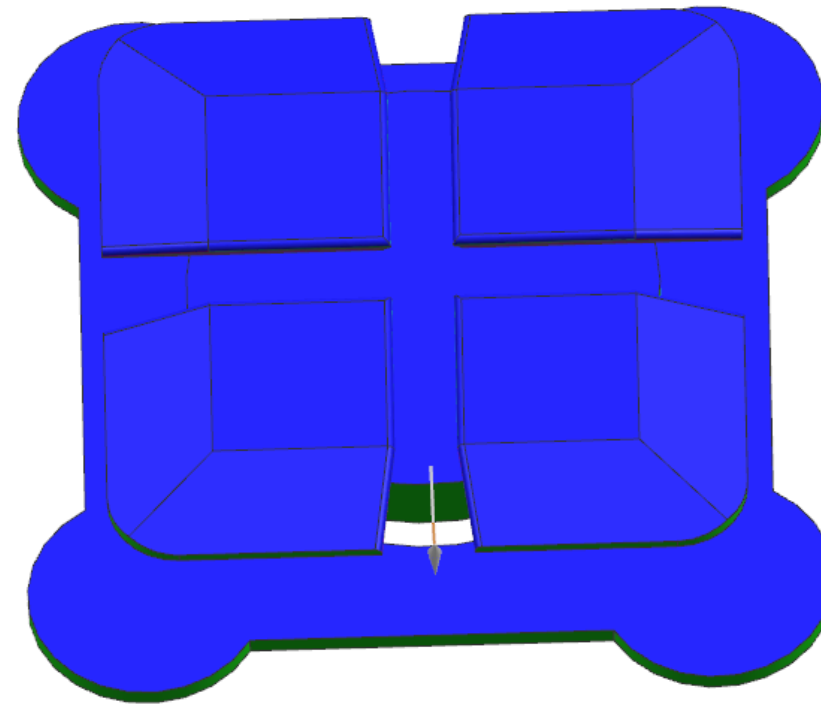
This boss does not have any draft angle on the green surface,
we suggest to add 1 degree draft angle by reducing plastics, please confirm?

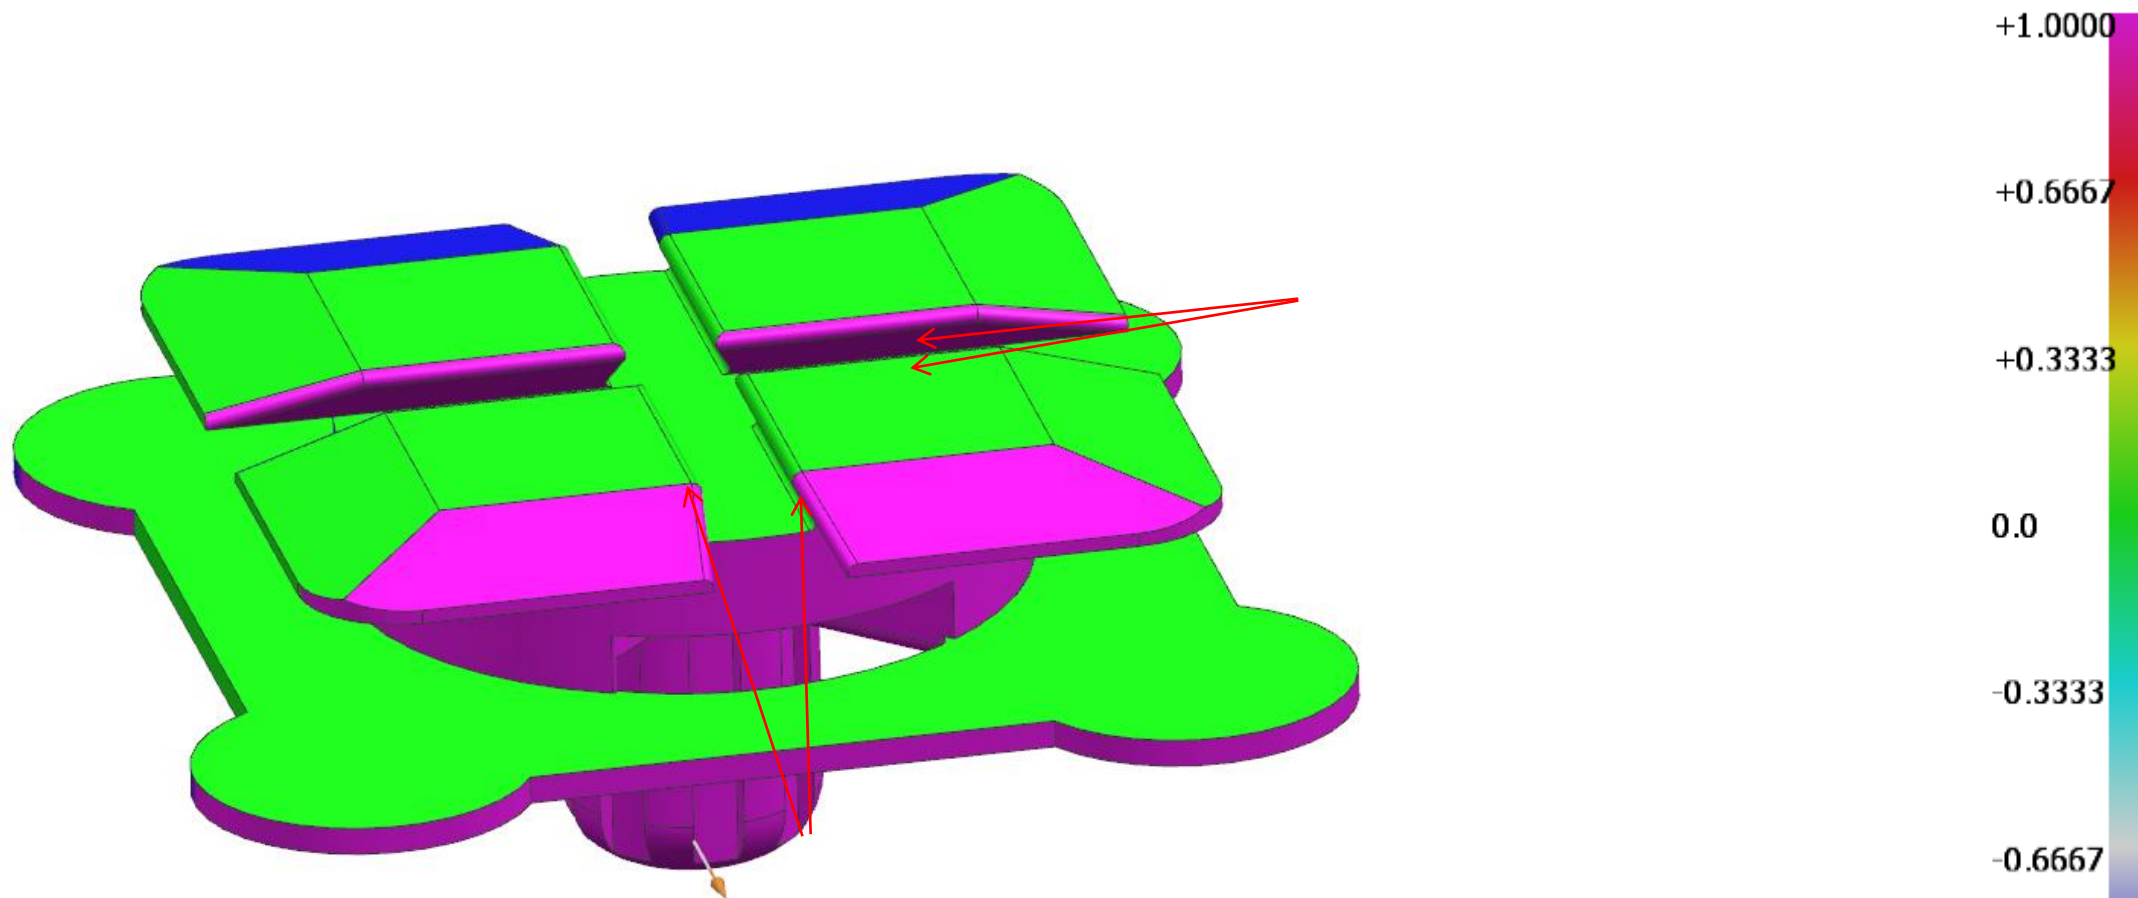
行位出模方向没有出模角，建议做
减胶拔模0.5度，请确认！共8处。

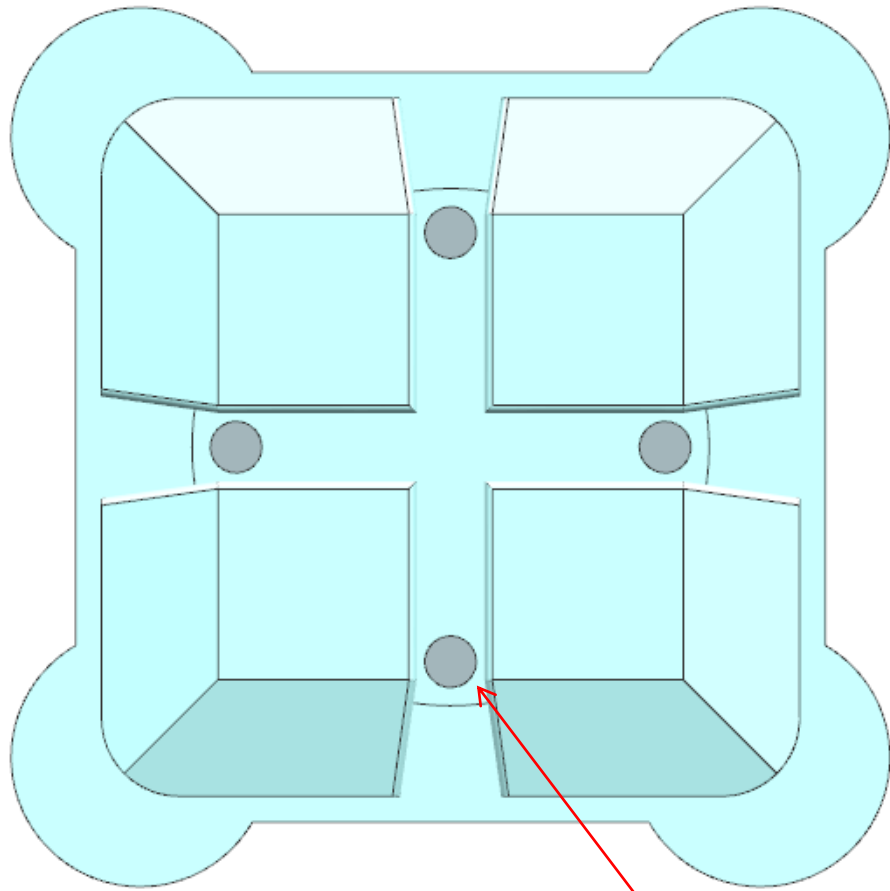
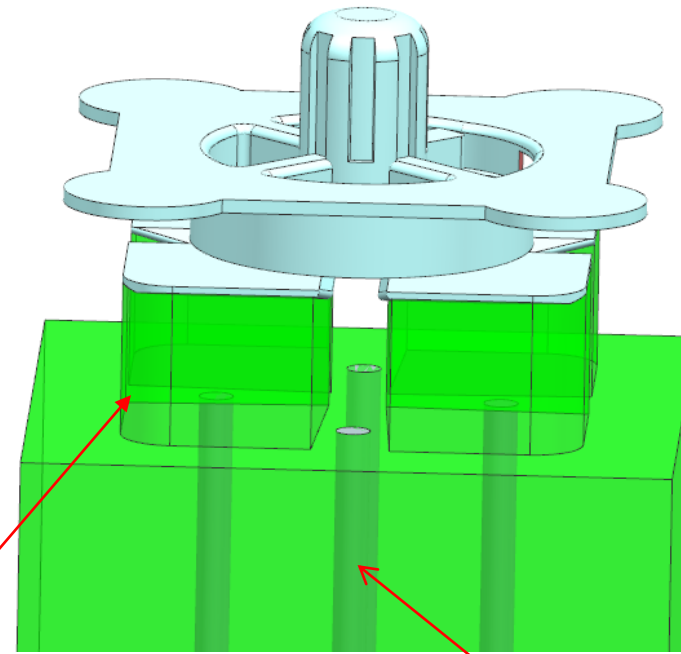
Ejector pins will be under the sliders, we will make earlier return systems to avoid ejection issue

Ejector pins diameter 2MM, this could avoid the ejector marks on the 4 plan surface,

total 4 pcs, please check if this is ok?

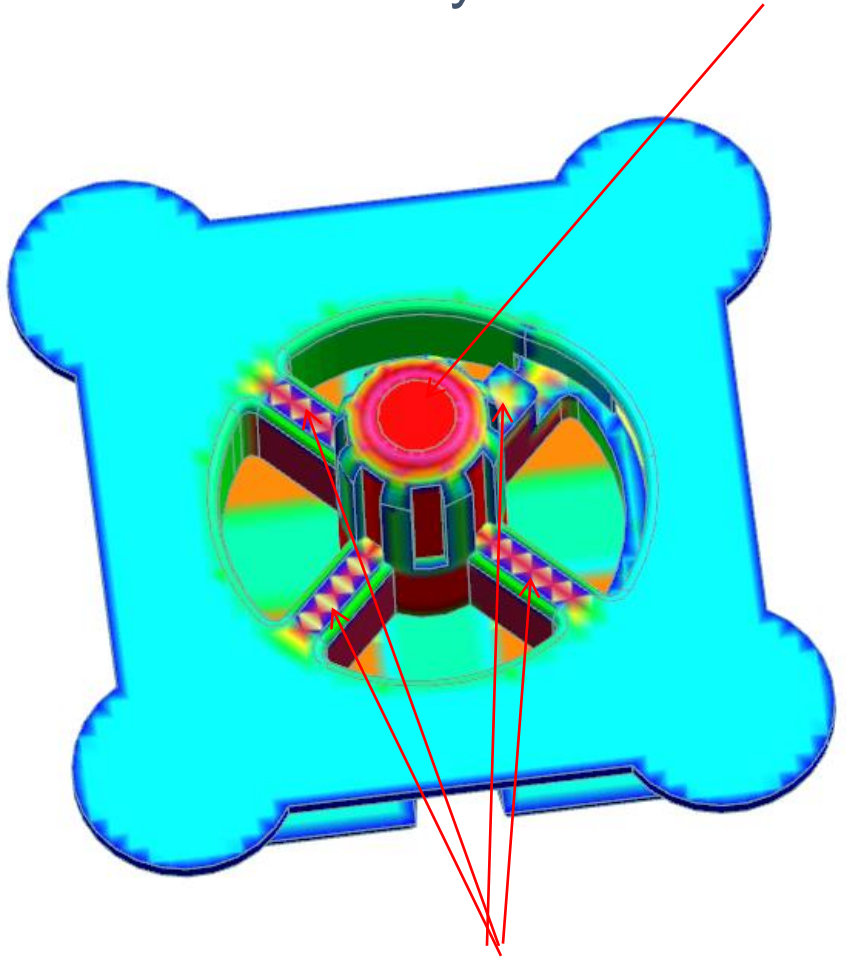
This boss will have sink mark due to unbalance wall thickness

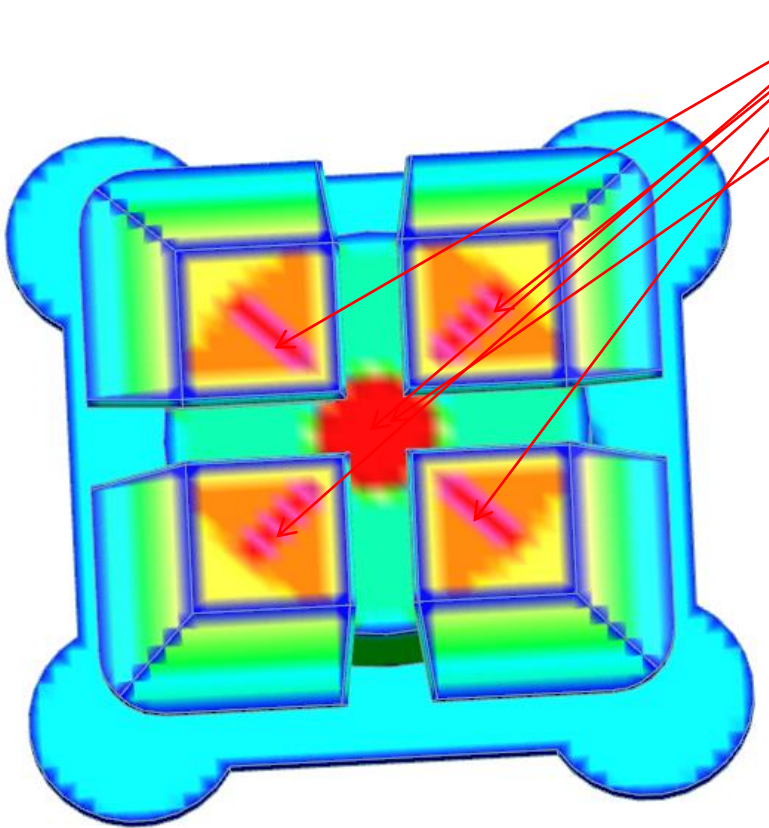
Those ribs are too thicker, may have some sink marks issue

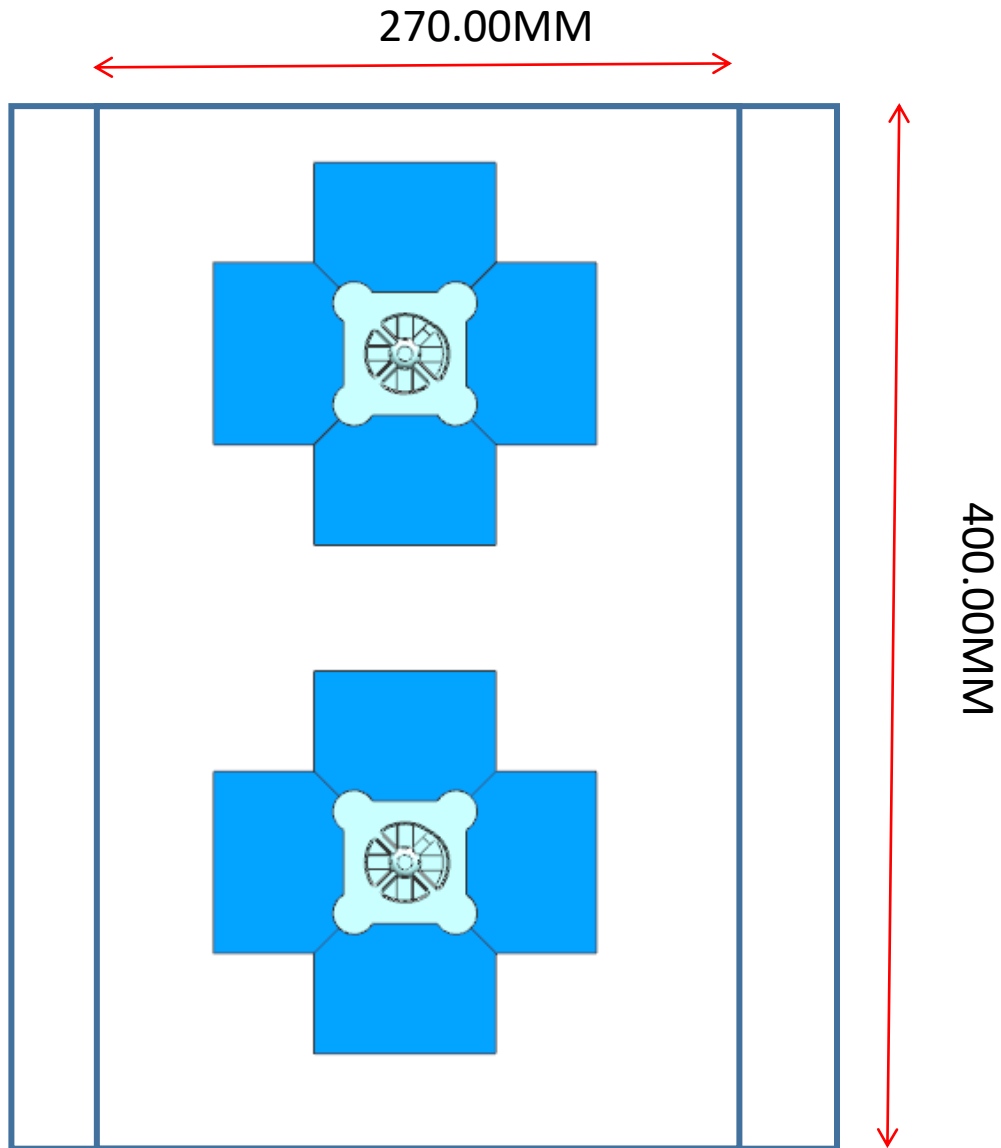
This area today is 0.5mm only, we suggest to add to 1mm, please check and confirm?
